AVL Jacquard Loom Cylinder-Valve Type Troubleshooting Guide

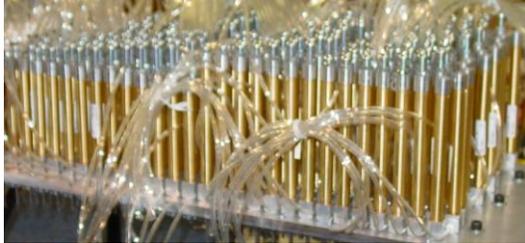
Teco Cylinders during Assembly

It is easy to tell the cylinder types apart by their color. Teco cylinders are gold and TPC cylinders are silver. Another difference is that the Teco cylinders are secured using a castle nut and require a special AVL castle nut tool to remove them. The TPC cylinders are secured by standard hex nuts and may be accessed with a standard deep socket.

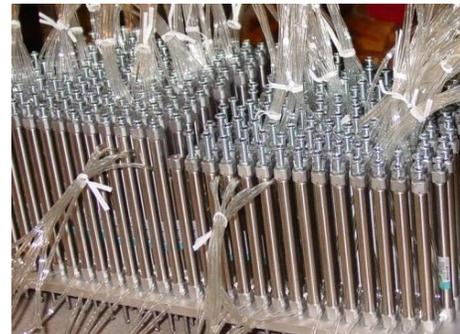
TPC Cylinders during Assembly

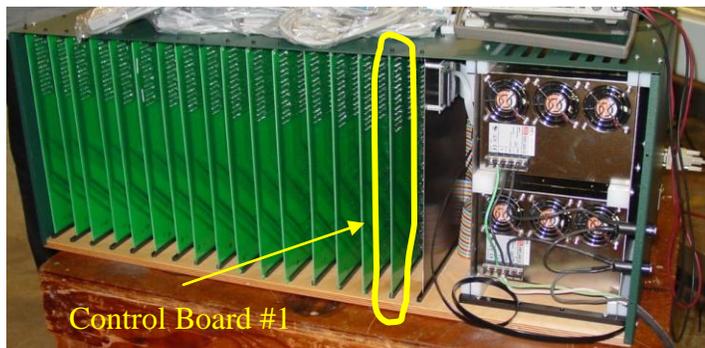
Remove the rear panel using a Phillips screwdriver to gain access to the Control Boards. You might also consider removing the top of the Control Box if accessing the Ribbon Cables at the rear of the Control Board. However, replacing the top can be difficult as it requires getting each control board into its proper slot/holders which are located in the

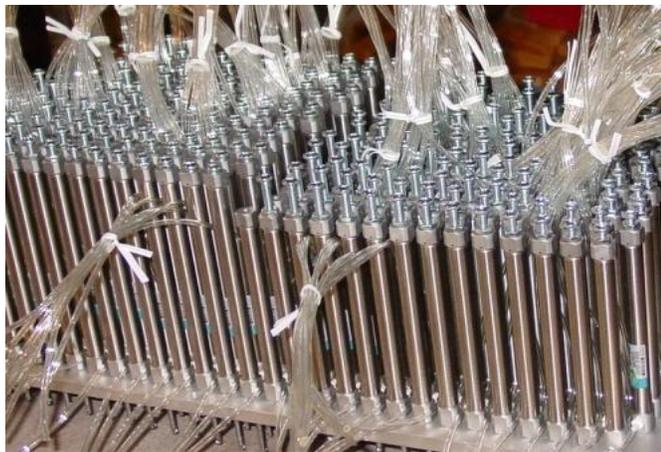
Hook Travel Adjusting Screws and Jam Nuts on TPC Cylinders

You may see a hook-travel adjusting screw and jam nut on the top of the Cylinder. If so, you will use a deep socket wrench and appropriately sized socket to hold the Jam Nut on the Cylinder while loosening the nut from below. If not, hold the Cylinder top with a pair of Pliers. Each Cylinder type has a different hold down nut. The Teco Cylinder uses a Castle nut. As there is insufficient room for a standard socket, an AVL Castle Nut tool must be acquired for use in removing the Teco Cylinder. The alternative to acquiring the tool from AVL is to acquire the same size Castle nut to use as a tool. Engage the tool Castle nut's teeth with those on the Cylinder Castle nut of which you want to remove. Then engage the tool Castle nut's body with a short socket or wrench.
